NATIONAL AERONAUTICS AND SPACE ADMINISTRATION

FINAL REPORT

DELTA 85 ANOMALY REVIEW COMMITTEE

DECEMBER 1, 1971

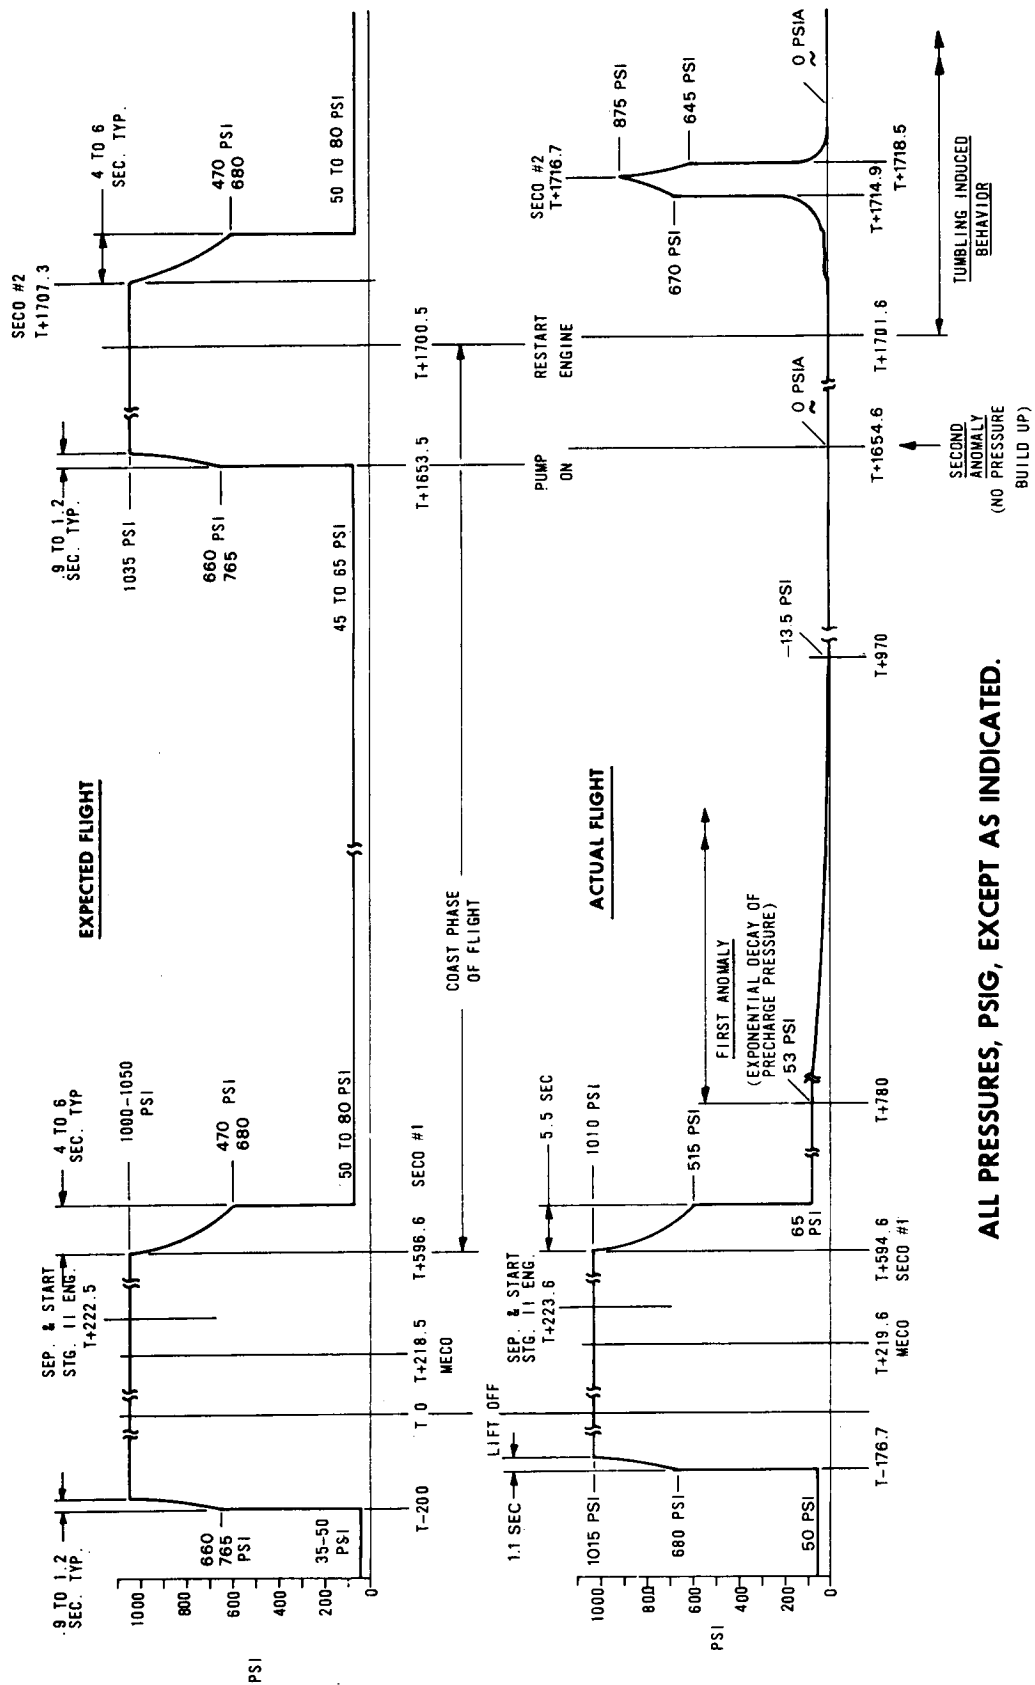
FIGURE 2-1, SECOND STAGE HYDRAULIC SYSTEM PRESSURE PROFILES, DELTA 85

Through first stage powered flight and the first burn of the second stage, hydraulic pressures remained stable, as expected (Figure 2-1).

At T+1654.6 seconds the hydraulic motor pump was turned on in preparation for restart; hydraulic pressure failed to respond (Figure 2-1). At pump turn-on, the engine battery voltage telemetry trace indicated the introduction of approximately a 20 amp electrical load. With a properly functioning hydraulic system, this load should have been about 35 amps.

As shown in Figure 2-1, second stage hydraulic system pressure should have been approximately 1000 psi at the time of second stage ignition, and should have begun its characteristic shutdown decay with SECO-II, at about T+1708 seconds.

The first anomaly in the flight data occurred approximately 180 seconds after SECO-I, at T+780 seconds (see Figures 2-1 and 2-5). A non-linear decay of the hydraulic system pressure began at this point and extended through most of the coast period prior to second stage restart.

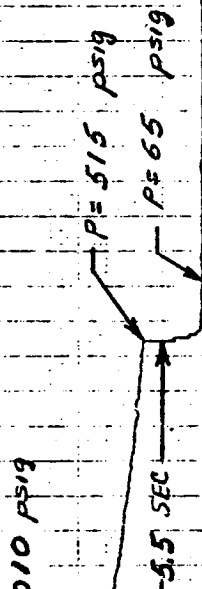
FIGURE 2-4, SECO-I SYSTEM BLEED DOWN

At SECO-I the hydraulic pump was turned off and the system bled down to the accumulator precharge pressure in 5.5 seconds (Figure 2-4). The bleeddown trace compares closely to those noted on numerous other Delta missions.

The system pressure was 65 psig immediately following post-SECO-I bleeddown (Figure 2-4). Thereafter, pressure decayed at a slow, steady rate until T+780 seconds at which time the pressure was 53 psig (Figure 2-5).

The system bleiddown immediately following SECO-I was normal. The slight roundness of the trace near accumulator depletion (see Figure 2-4) has been noted before on numerous missions (BIOS-B, Intelsat II F2, TOS-C, Intelsat III F, and others) and results from a slight amount of air entrainment in the hydraulic system. This entrained air is not considered to be significant to the Delta 85 anomaly.

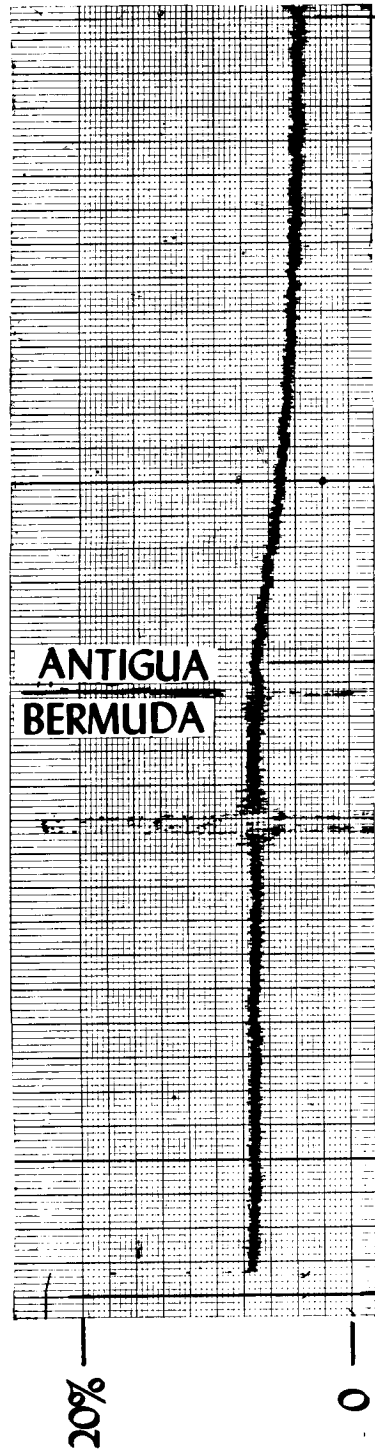
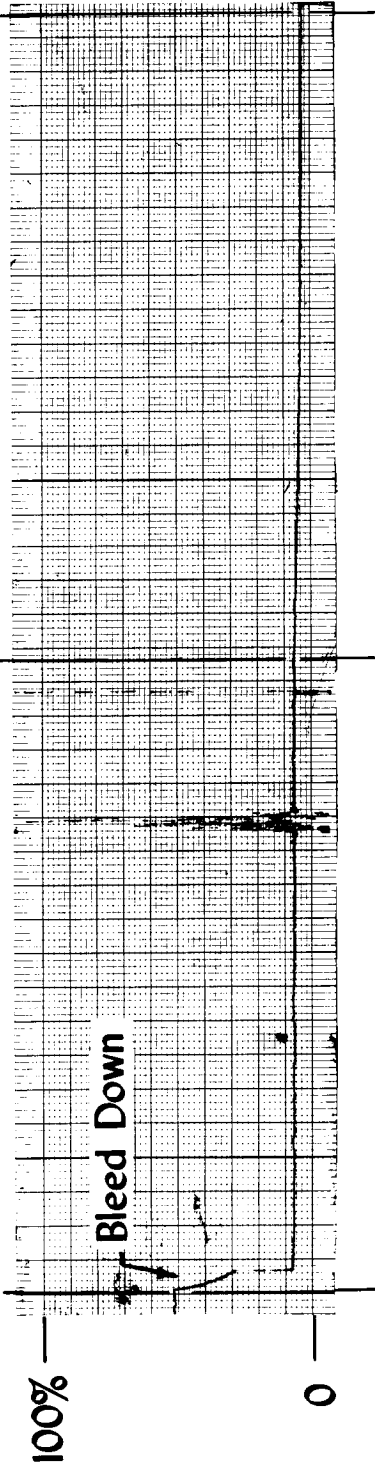
FIGURE 2-5, TELEMETRY TRACE - DELTA 85, HYDRAULIC, SHOWING INITIATION OF PRESSURE DECAY AT T+780

From T+780 seconds to T+970 seconds, the pressure decayed significantly at what appears to be an exponential rate. At T+970 seconds the transducer indicated nearly zero psia, and remained at that level until T+1705 seconds. Figure 2-5 provides an amplified replay of telemetry data obtained during most of this pressure decay period.

An analysis of the pressure decay rate commencing at  $T + 780$  seconds indicates that the leak rate corresponds to an equivalent orifice of approximately .006 inch diameter, or roughly the size of a small grain of sand. As shown in Figure 3-2, gas leakage is possible past the static o-ring seal on the end cap of the reservoir, past the dynamic o-ring seal surrounding the dip stick, and out the fill port through the nitrogen precharge valve (Figure 3-3). Leakage past the piston o-ring which seals the fluid/gas interface is not suspect since it would not correlate with observed data.

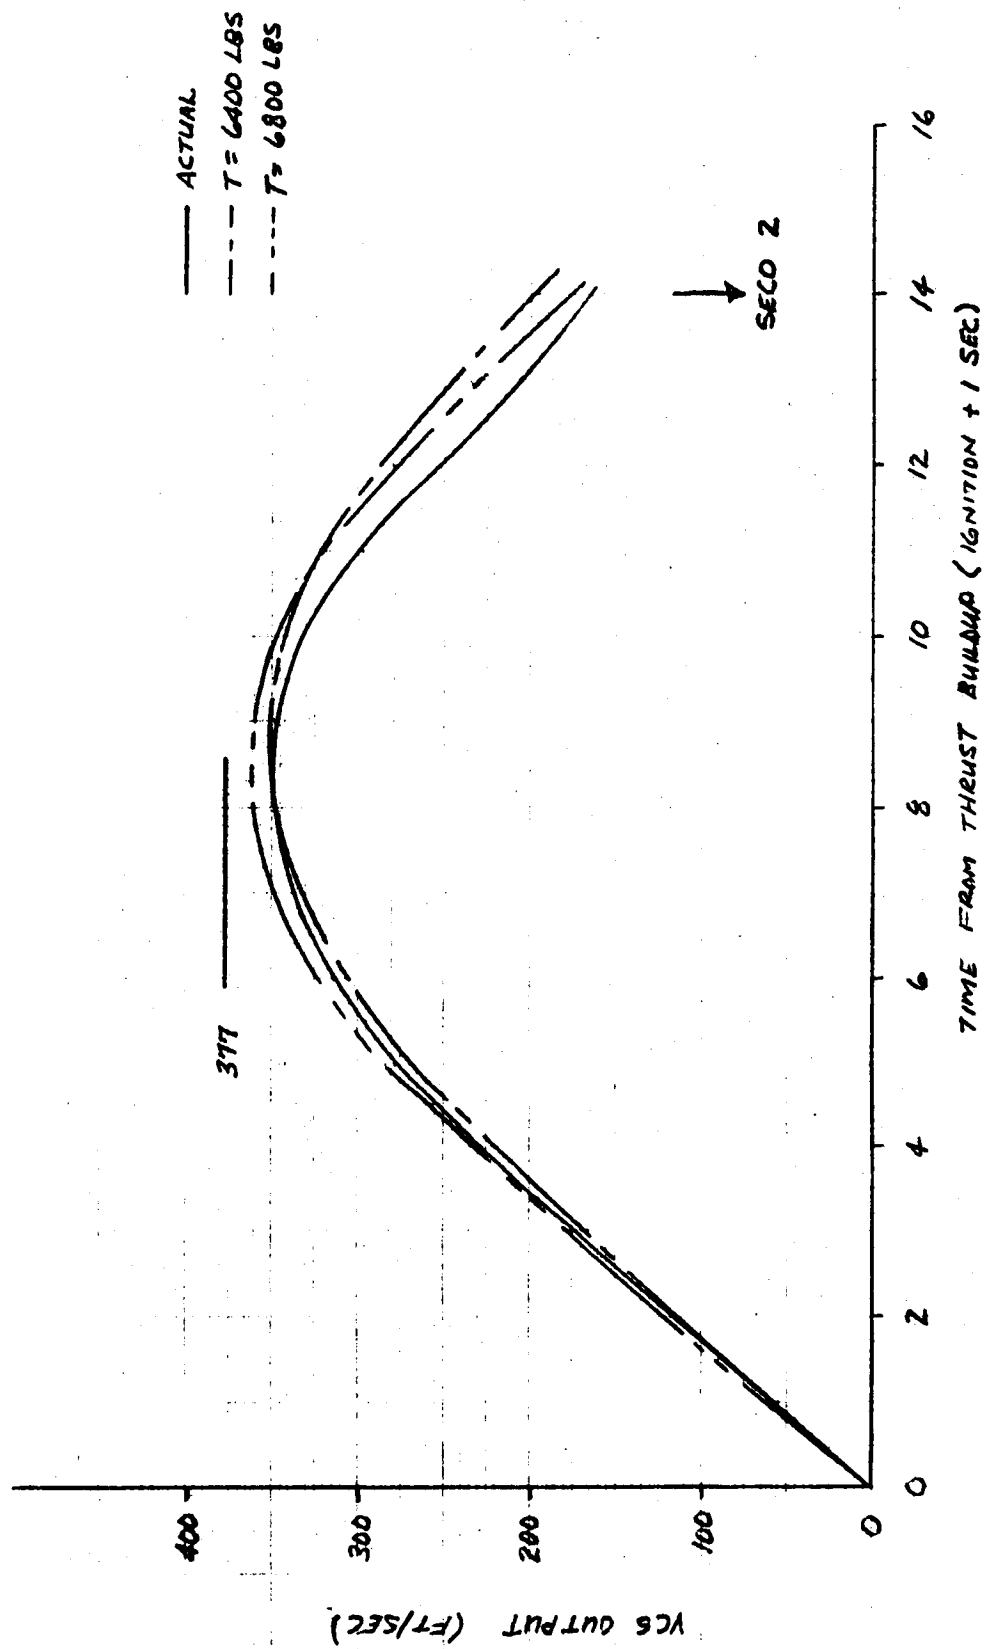
FIGURE 2-9

Figure 2-8 defines the location of the VCS along with other pertinent parameters. The integration of engine motion results in the vehicle rates indicated in Figure 2-9. These rates cause a centrifugal acceleration which counteracts the axial acceleration caused by engine thrust. This "negative" acceleration results in a lower VCS output than would be expected during normal operation. Figure 2-10 shows the actual telemetered VCS output along with calculated outputs for second stage thrust levels of 6400 lbf to 6800 lbf. Good correlation between the actual and predicted VCS output is evident, confirming that VCS operation was normal when vehicle motion is considered, and that it should not have issued a SECO command.

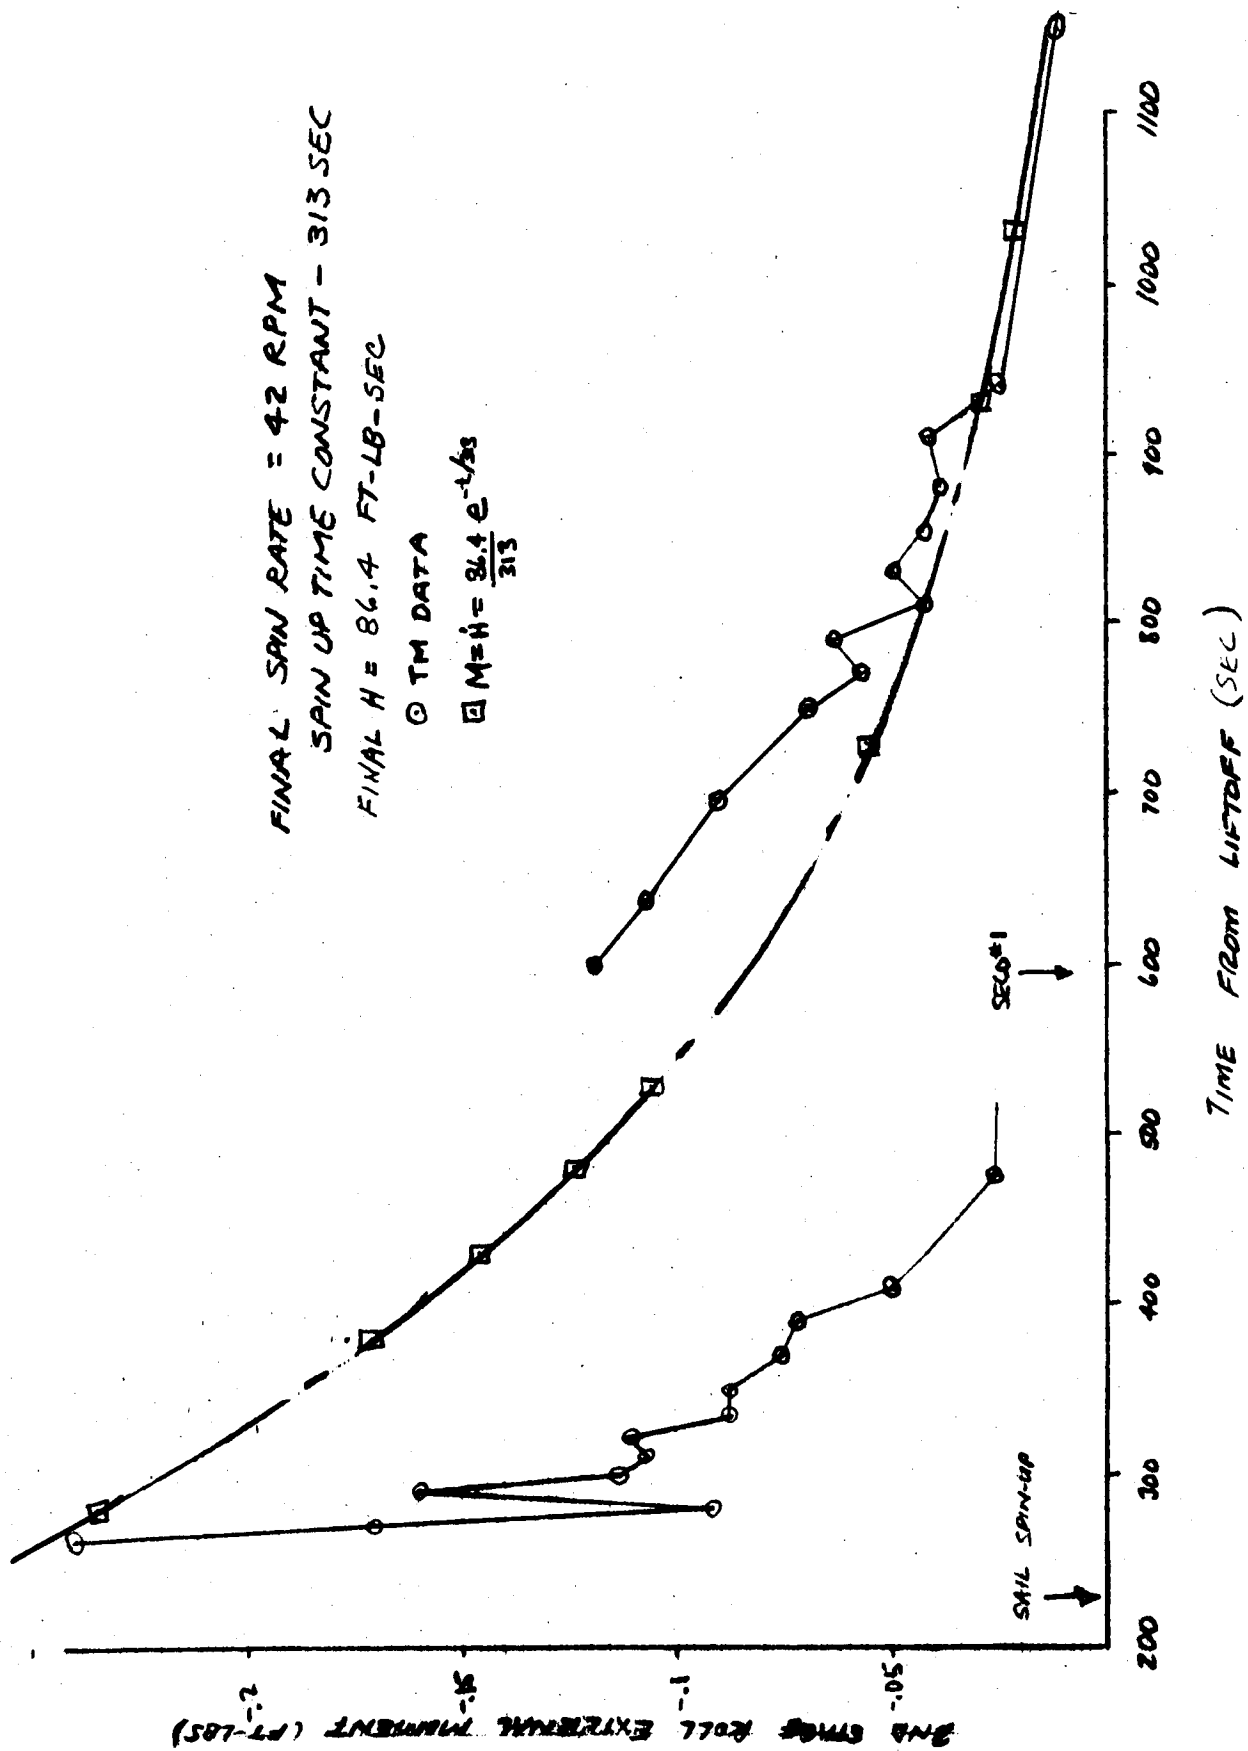
FIGURE 2-II

An abnormal roll transient occurred at the onset of second stage restart, which can be attributed to the pitch and yaw deflections of the thrust chamber. As can be seen from Figure 2-11, the transient began as the main engine goes hard-over in the pitch and yaw planes. A roll moment would result if the vehicle roll center of gravity and main engine gimbal points were offset. An offset of approximately 0.07 inches (approximately 3.1 ft-lbs of roll moment for hardover engine) would cause the observed roll motion. This magnitude of offset is easily within the realm of system tolerances. The roll transient is damped by the roll jets and dies out after the engine is shut down.

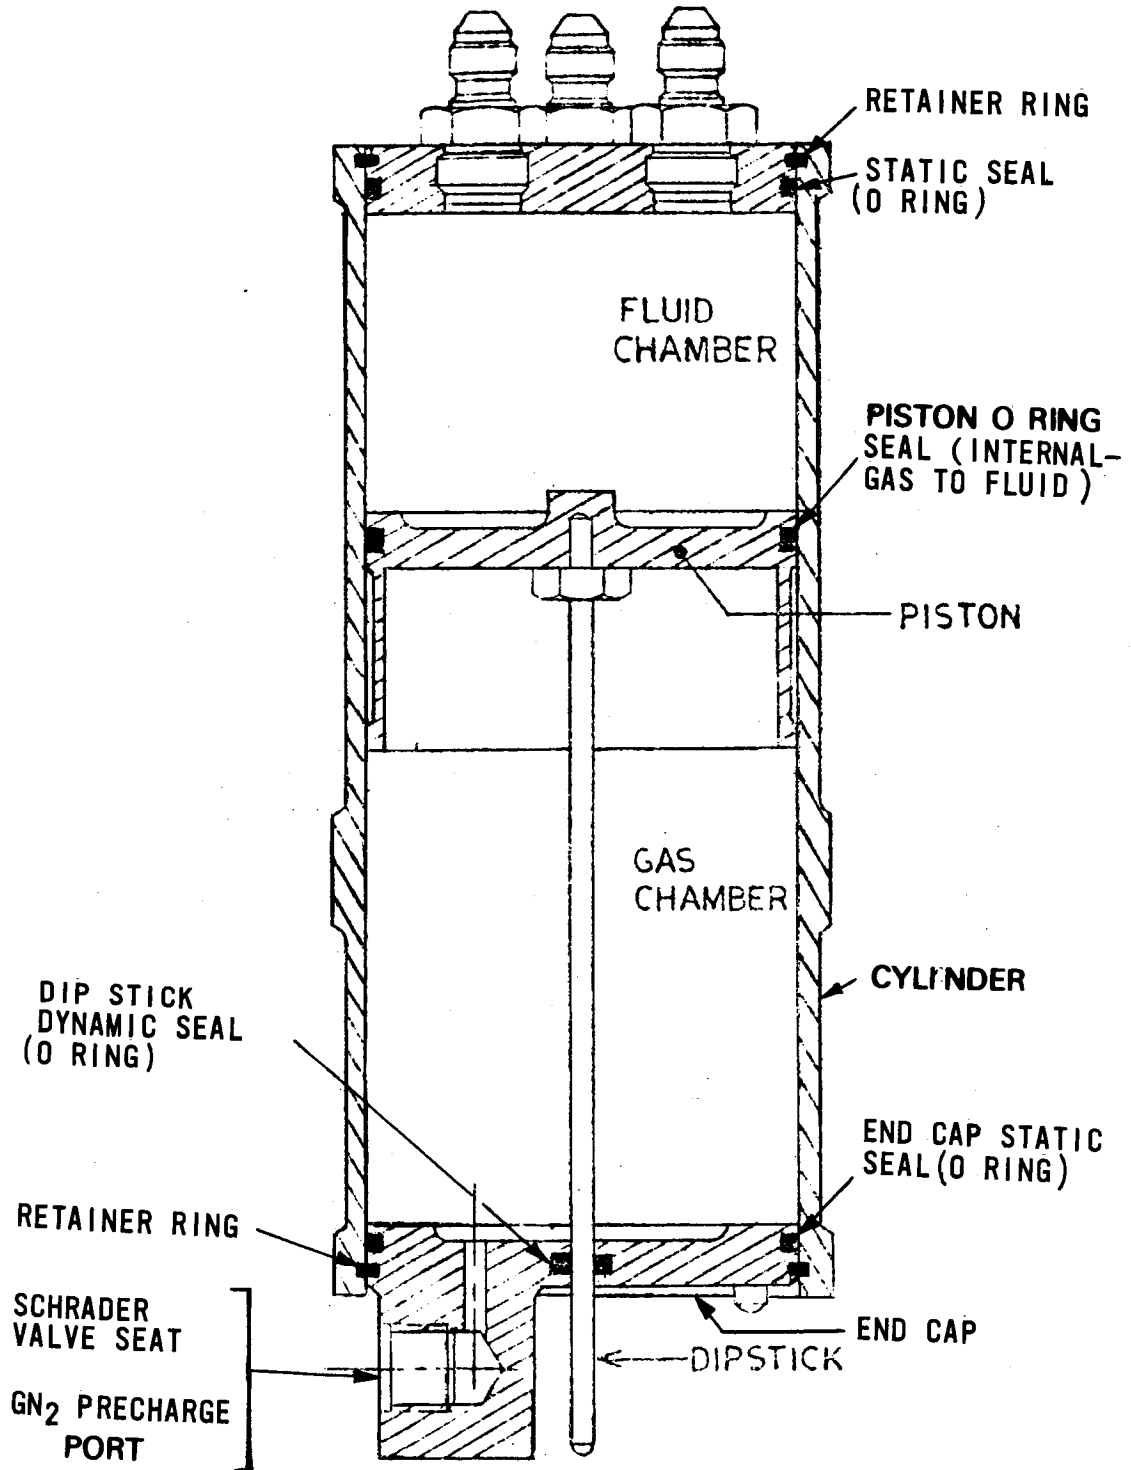
FIGURE 3-1, DIAGRAM-DELTA 85, STAGE II HYDRAULIC SYSTEM

As shown in Figure 3-1, a guard is provided to protect the dip stick from being bent or damaged during handling and after installation. It consists of a flat piece of sheet metal (painted red) wrapped around most of the reservoir cylinder

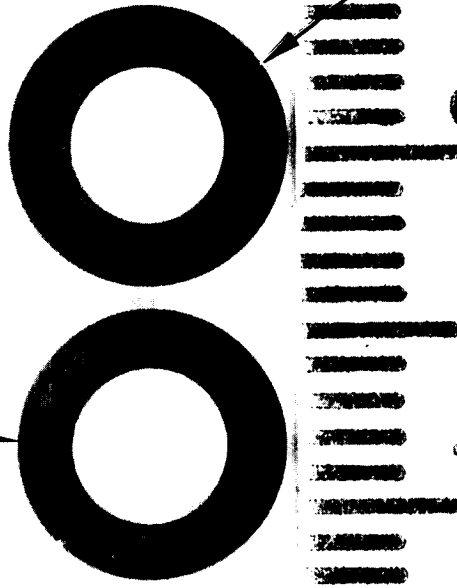
O-RING FROM DEMONSTRATION  
MODEL, AGE UNKNOWN  
( PRIOR TO 1967 )

VIEW SHOWING APPARENT DIFFERENCES  
IN SIZE BETWEEN SAMPLES.

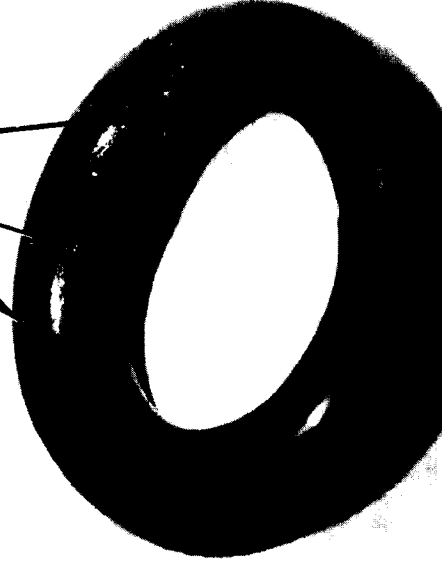
1. Lack of adequate lubrication of the O-ring could have been one of the primary contributing factors in creating the nitrogen leak.
2. Rolling of an O-ring seal in the unlubricated state was verified by wear noted on the O-ring removed from the display model.
3. There is a significant dimensional difference in O.D. (+.006 inch) between the old and current O-ring (see Figure), yet the seal cavity has remained unchanged. This could increase binding and might account for the higher than normal piston friction that was encountered during the reservoir acceptance tests. In the unlubricated state, this could contribute to more rolling of the seal.

VIEW SHOWING ABRASION DUE TO LACK  
OF LUBRICATION AND ROLLING OF O-RING.  
( FROM DEMONSTRATION MODEL )
